October 2002

MAINTENANCE BULLETIN

Alfa Company

Construction Battalion Center

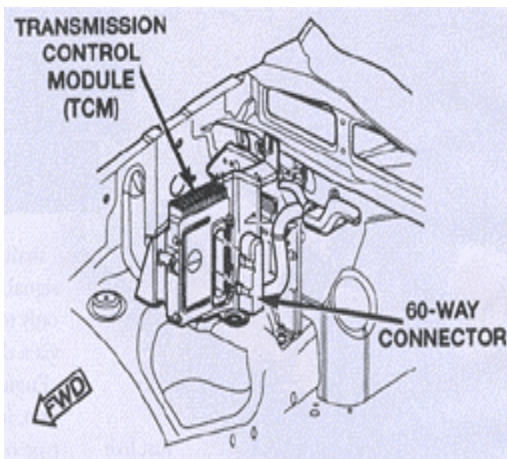
Location of the Transmission Control Module on the Chrysler 45RFE electronic automatic transmission.

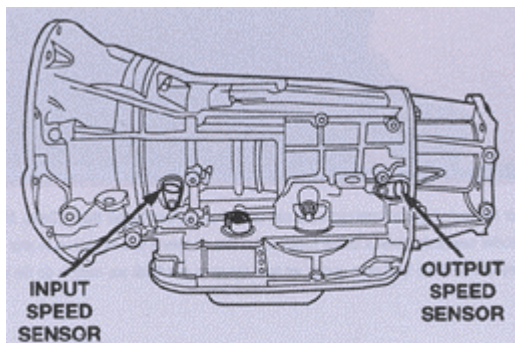
Locating the Input and Output Speed Sensors on Chrysler's 45RFE unit.

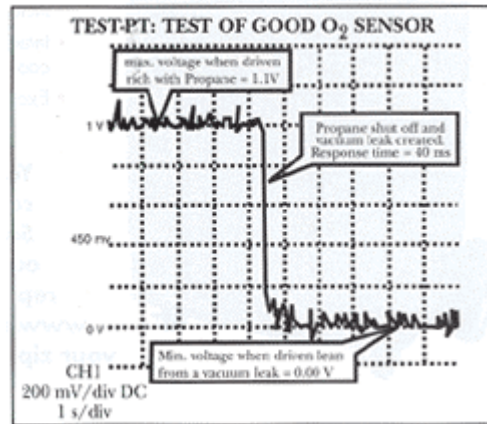
Knowing What's Bad

Typically, a bad O₂ sensor will read low (lean), which causes the engine to run too rich, pollute too much and use too much gas. A low reading can be caused by several things: old age, contamination, a bad wiring connection, or an ignition or compression problem in the engine.

Also, as an O₂ sensor ages, it doesn't react as quickly as it once did. The increased lag time makes the sensor sluggish and prevents the engine from keeping the air/fuel mixture in close balance. If the engine burns oil or develops an internal coolant leak, the sensor element may become contaminated, causing the sensor to fail. Keep in mind that O₂ sensors need to be hot (617° F to 662° F) to produce a voltage signal. It may take a few minutes for the exhaust to heat up the sensor, so most O₂ sensors in newer vehicles have a built-in electrical heater circuit to get the sensor up to temperature as quickly as possible. These are usually three-wire and four-wire O₂ sensors. The single- and two-wire O₂ sensors are unheated.
